Manhole Inspection Summary

Manhole # S55Q__002MH

Insp Date: **7/28/08 2:59 PM**

Location Address: **3400 boston st**

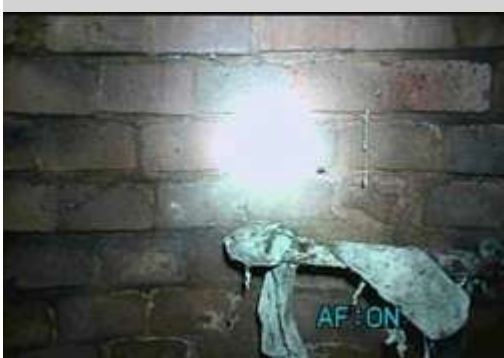
Defect 2

Surcharge ☒ **Evidence Of Surcharge** Depth: **5.2** (ft.) ☐ Active Surcharge Present

evidence of surcharge

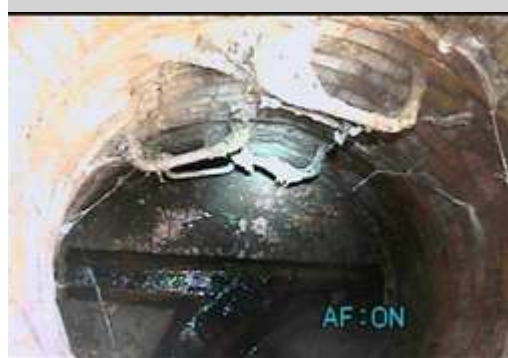
Defect 1

Steps Count: **4** Missing: **0** ☒ **Corroded**

cor. steps

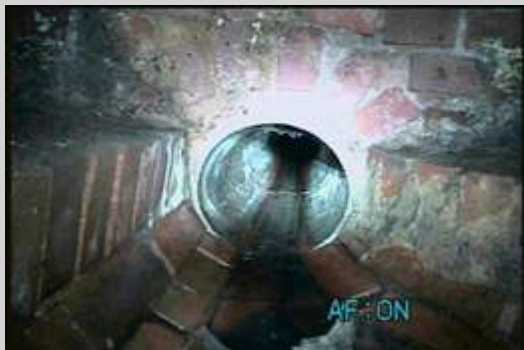
12 O'Clock Outflow

8 in. Circular Gravity Sewer
Pipe Out @ 12 O'Clock

Pipe Material: **Clay** ☐ Pipe Lined

Invert Depth: 7.00 (ft.) Flow Characteristics: **Slow**

Deposits: ☒ None ☐ Mud ☐ Sludge ☐ Debris ☐ Grease

Infiltration: **None** Pipe Seal Cond: **Unknown**

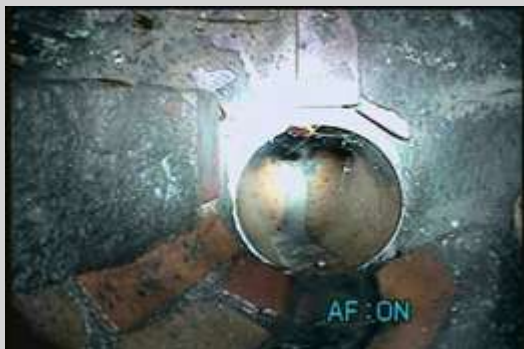
3 O'Clock Inflow

8 in. Circular Gravity Sewer
Pipe In @ 3 O'Clock

Pipe Material: **Clay** ☐ Pipe Lined

Invert Depth: 6.92 (ft.) Flow Characteristics: **Slow**

Deposits: ☒ None ☐ Mud ☐ Sludge ☐ Debris ☐ Grease

Infiltration: **None** Pipe Seal Cond: **Unknown**

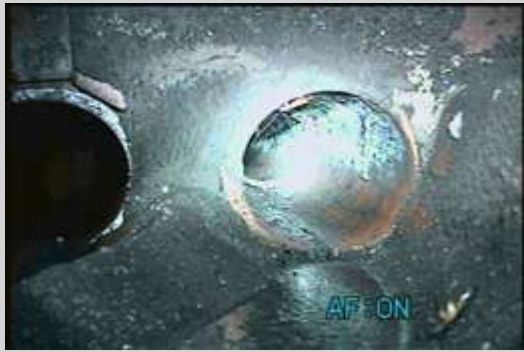
4 O'Clock Inflow

Pipe In @ 4 O'Clock

Pipe Material: **Clay** ☐ Pipe Lined

Invert Depth: **6.83** (ft.) Flow Characteristics: **None**

Deposits: ☒ None ☐ Mud ☐ Sludge ☐ Debris ☐ Grease

Infiltration: **None**

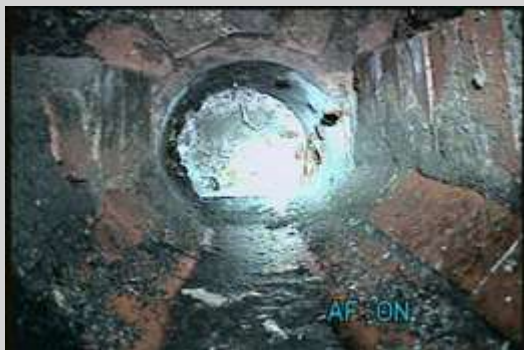
6 O'Clock Inflow

Pipe In @ 6 O'Clock

Pipe Material: **Clay** ☐ Pipe Lined

Invert Depth: **6.92** (ft.) Flow Characteristics: **None**

Deposits: ☒ None ☐ Mud ☐ Sludge ☐ Debris ☐ Grease

Infiltration: **None**
